Hackney Bigfoot Berth Condensation

Model: 30C10.11FR

Year: 2006

Date: 1 May 2008

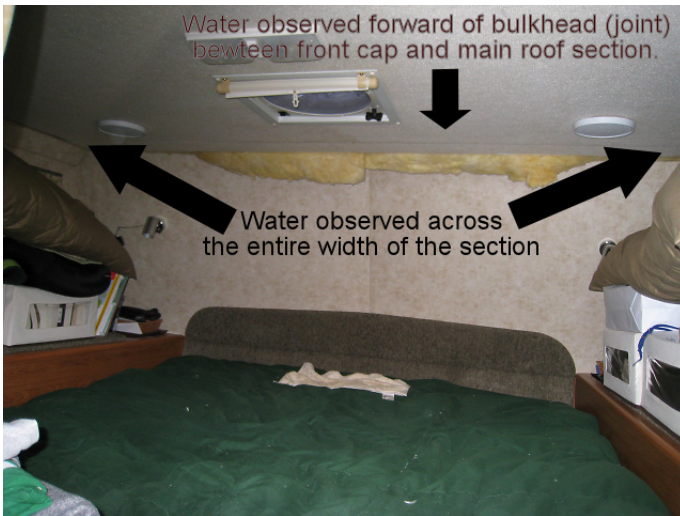
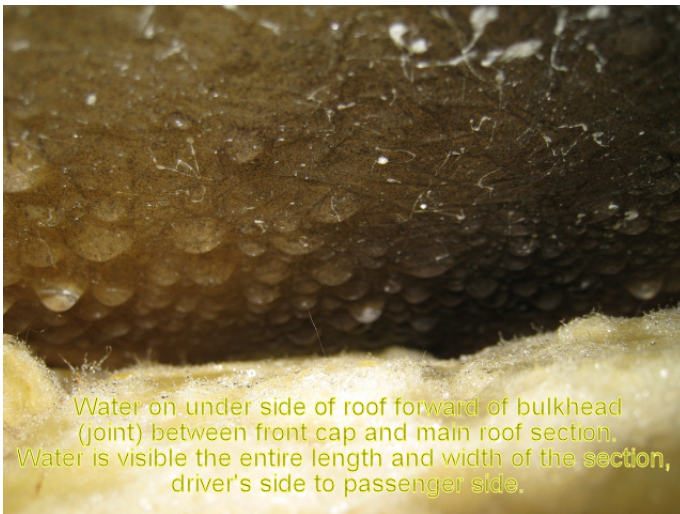
Affected Area

Water on the interior surface of the fiberglass forward of the bulkhead (joint) between the main roof section and the front cap.

I visually observed water on the interior side of the fiberglass across that entire section.

I also felt water on the interior side of the fiberglass on the vertical surface of the front cap.

I believe there are two possibilities for the cause:

1. The joint between the main and front cap sections is leaking badly enough for there to be water beaded up across the entire roof section and then migrating down the vertical surface of the front cap.
2. The water is coming from condensation.

I think possibility #1 is unlikely for several reasons. First, it implies a failure of the joint severe enough for ingress of enough water to cover all the surfaces, water that then propagated evenly around the entire interior surface of the front cap. The water is everywhere and not limited to a certain channel or path.

Therefore, I believe it is condensation.

In the past month we've been in frost conditions, then moved to an area of weeks of rain and high humidity.

Due to the low to mild temps we have not been running the berth fan(s), so the berth area has not been getting much ventilation.

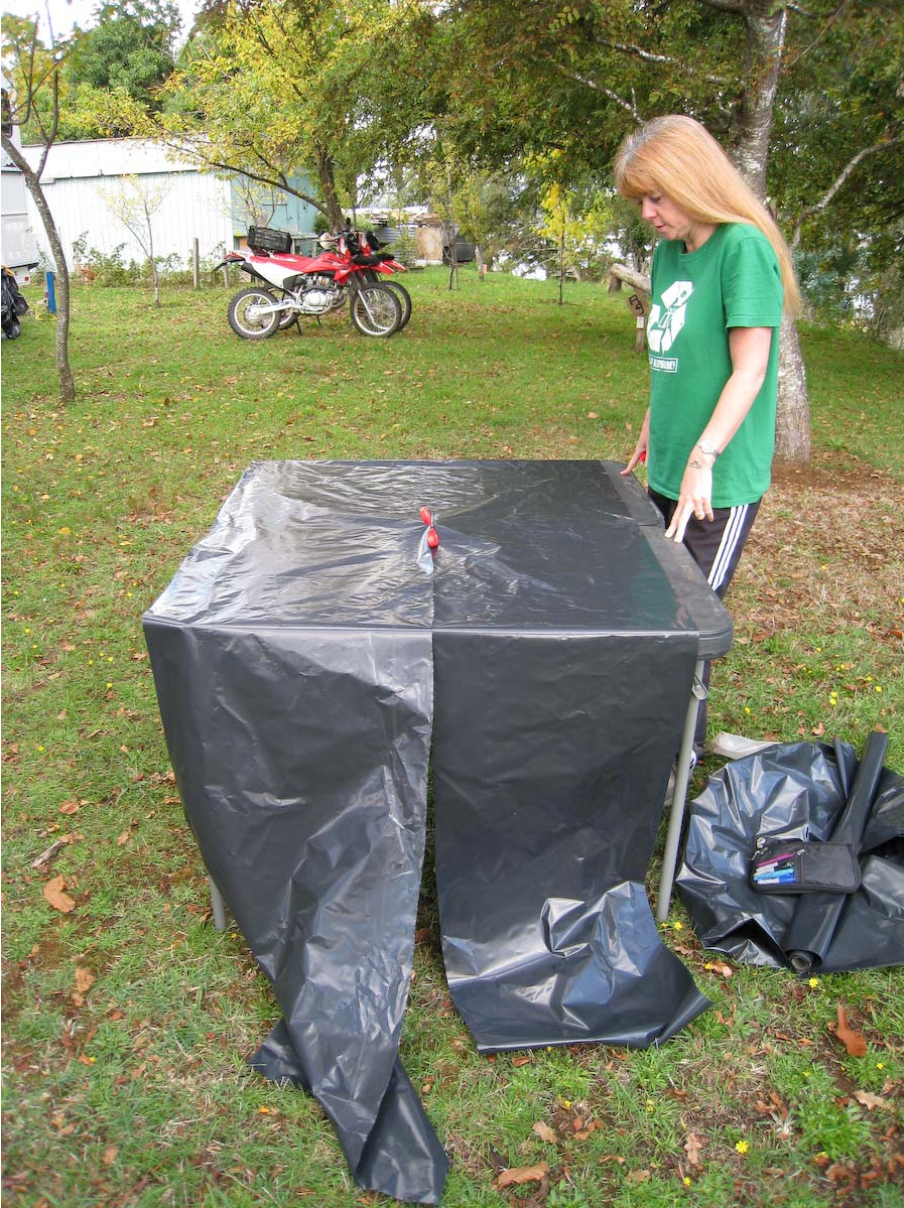
Cutting the vapor barrier.

4. Monitored the area during the rains of the same period to confirm the problem was condensation and not a leak of the bulkhead seal.
5. Installed a vapor barrier using plastic sheeting used in home insulation projects.

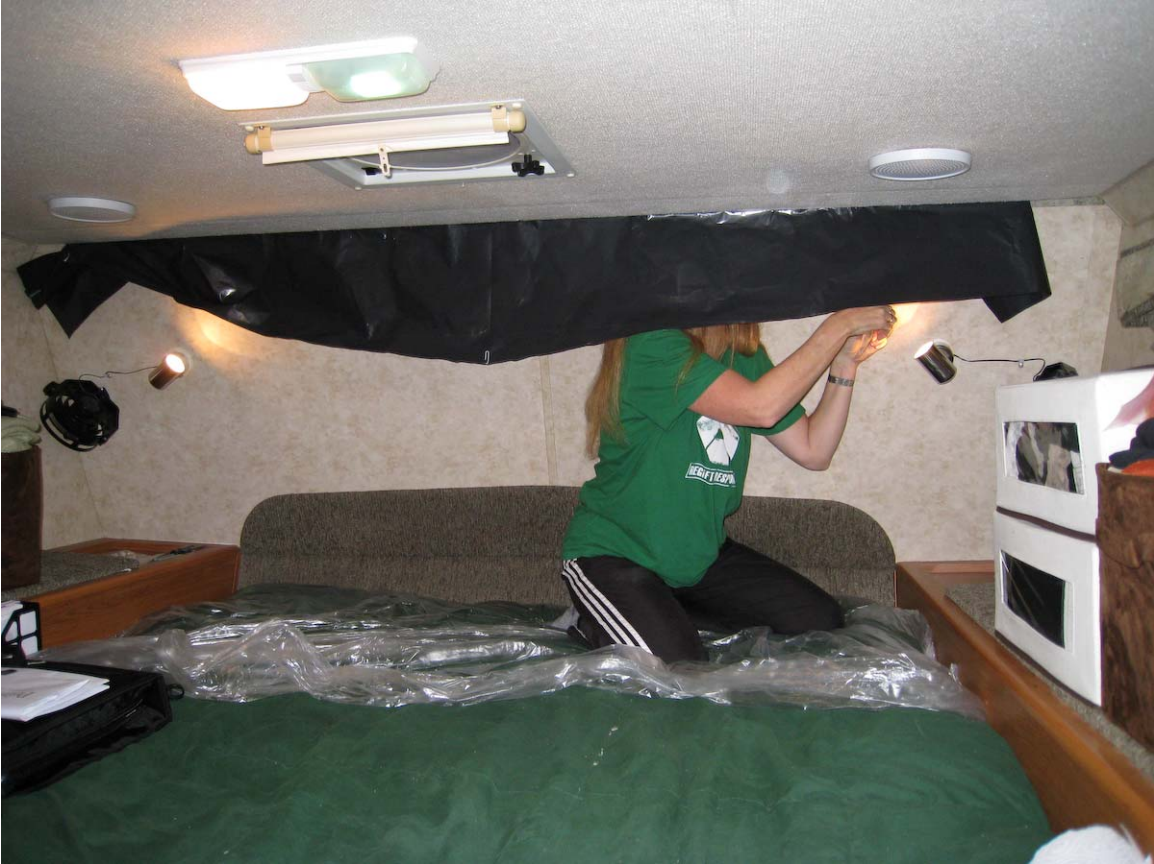
Installing the vapor barrier. Steph's hands were smaller and could get into the tight corners, so she got this job.

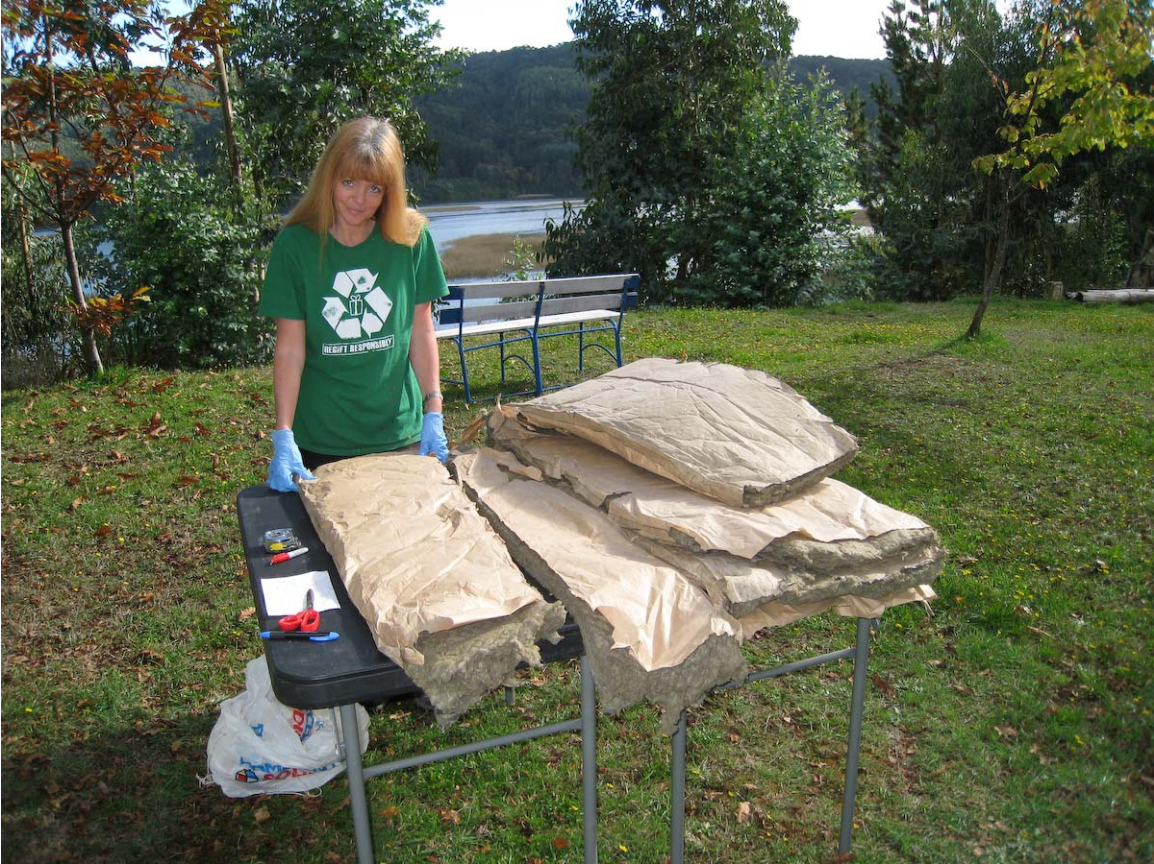
Cutting the insulation to fit. We very carefully cut two layers of pieces to fit the tapered spaces, overlapped so no joint would penetrate the installation. I ended up just stuffing the pieces in to fill all the air gaps, so almost all of this work was for unneeded.

6. Installed new fiberglass insulation in entire space above berth forward of front bulkhead. Packed insulation tightly to eliminate air gaps.
7. Tucked vapor barrier behind berth front paneling.

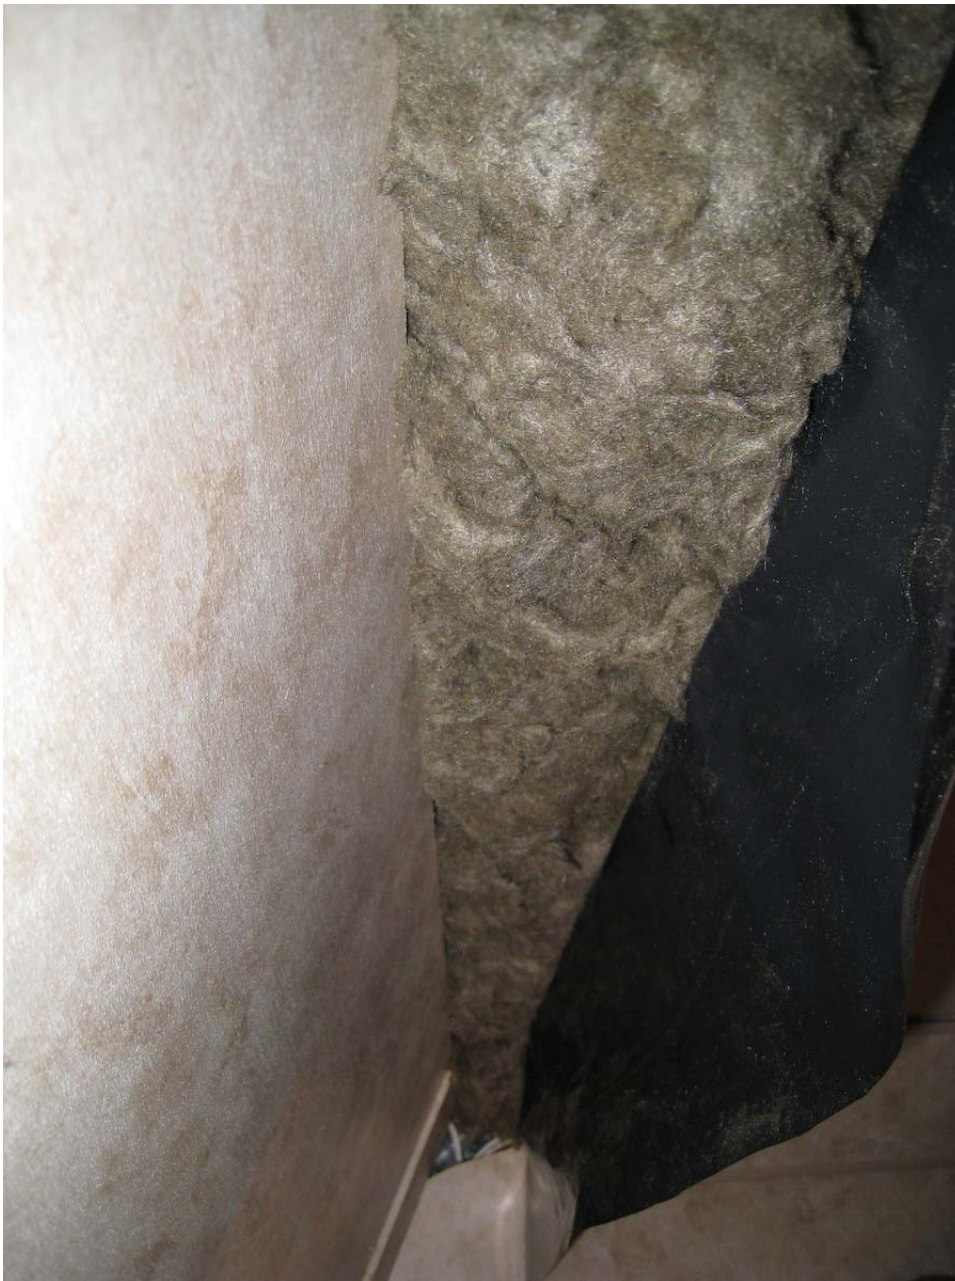
Insulation stuffed into the entire space between the forward bulkhead and the top of the forward wall panel.

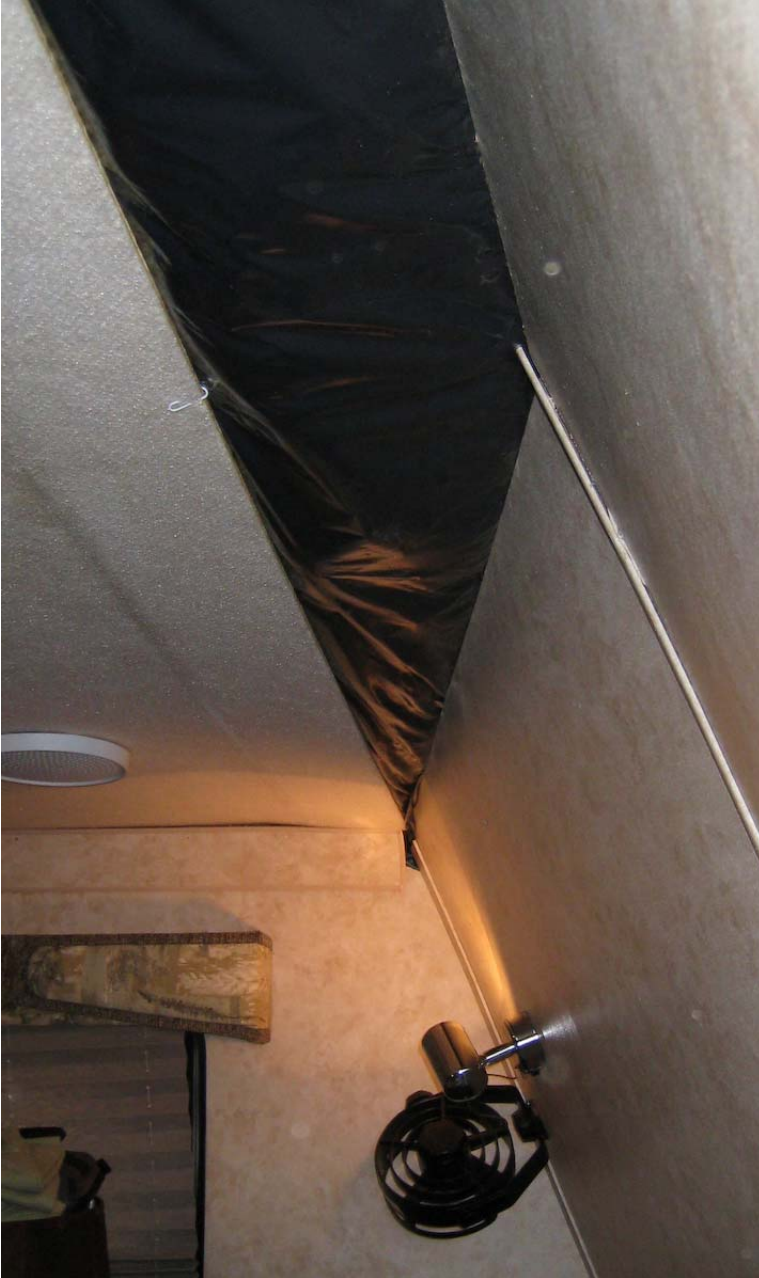
Moisture barrier extends from bulkhead and is tucked behind forward wall panel.

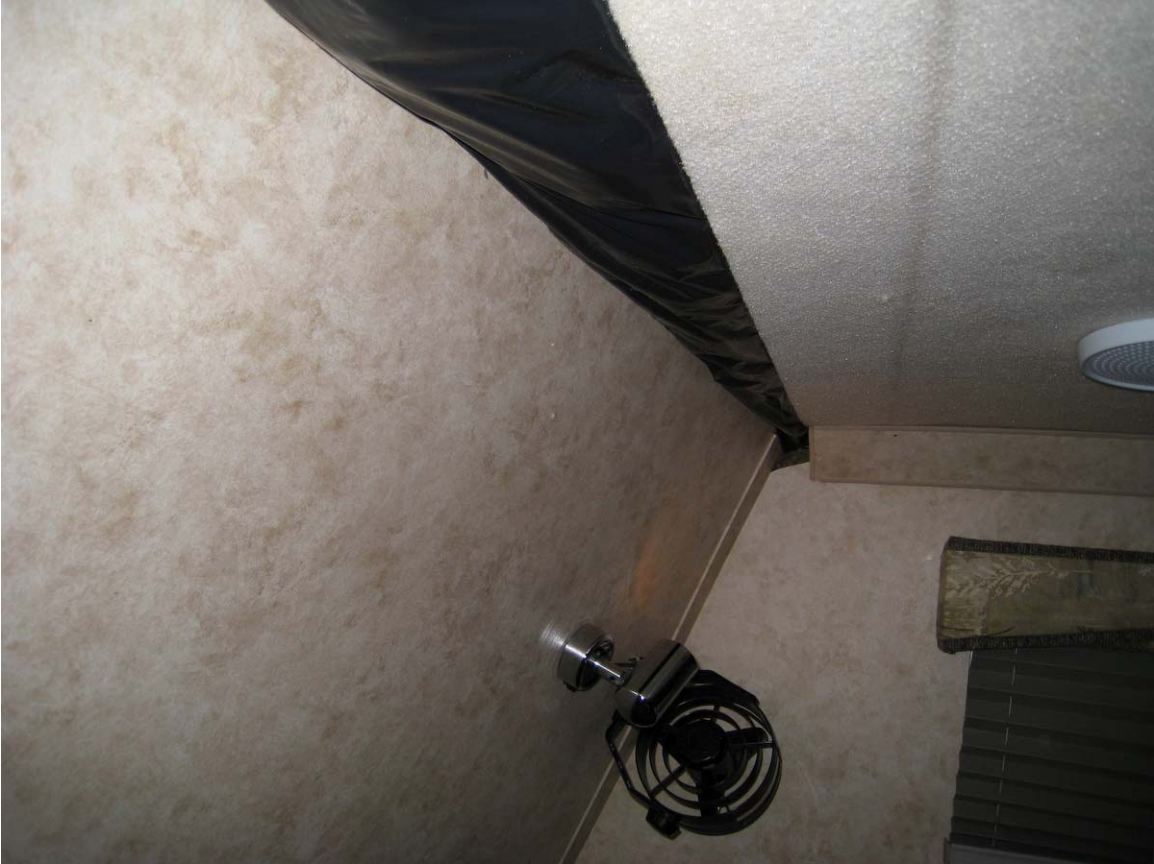
Moisture barrier extends from bulkhead and is tucked behind forward wall panel.
